NASA TN D-3571

# PROJECT FIRE PHOTOGRAPHIC SUMMARY AND RECORD OF REENTRY PHENOMENA AT HYPERBOLIC VELOCITIES

*by Charles W. McKee*  
*Langley Research Center*  
*Langley Station, Hampton, Va.*

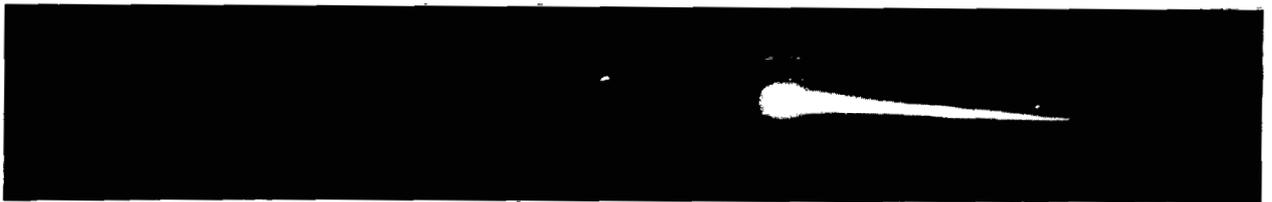
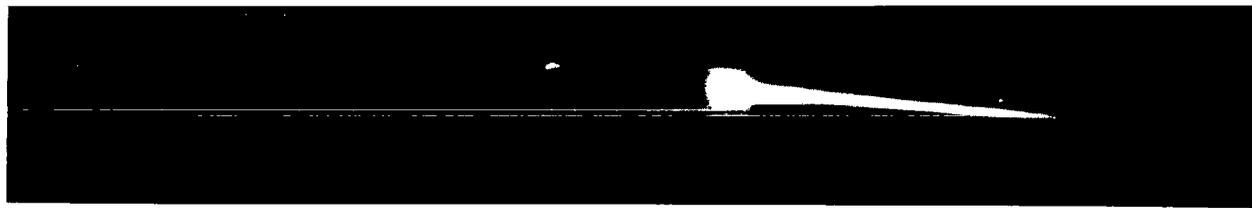
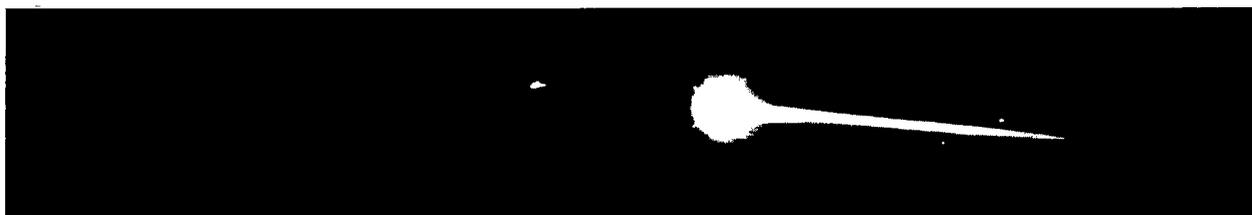
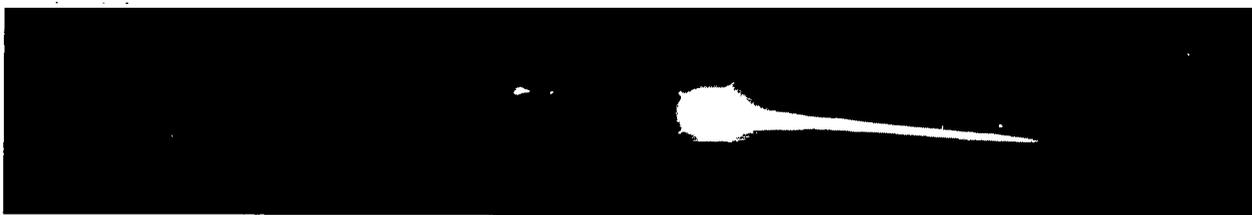
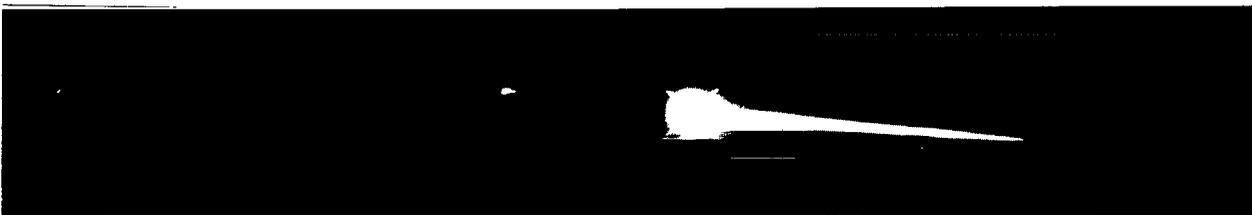
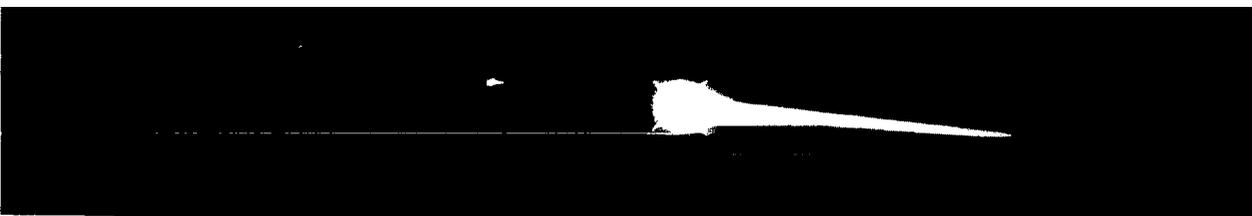
Sequence 4 continues to demonstrate the severe effects of tumbling by the flareup of the spent Antares (photograph 4C) and the beginning of breakup noted by separate pieces appearing to burn in the wake. Because of apparent camera motion this sequence was not used for separation measurements, but even with the camera motion the separation distance can be determined to be in excess of 450 meters and the spent Antares wake length in excess of 1400 meters.

During sequence 4 the reentry-package velocity changed from 11 271 m/sec at 1637.089 sec to 11 263 m/sec at 1637.255 sec.

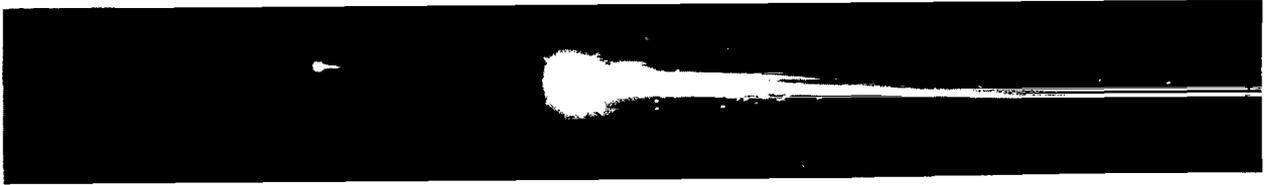
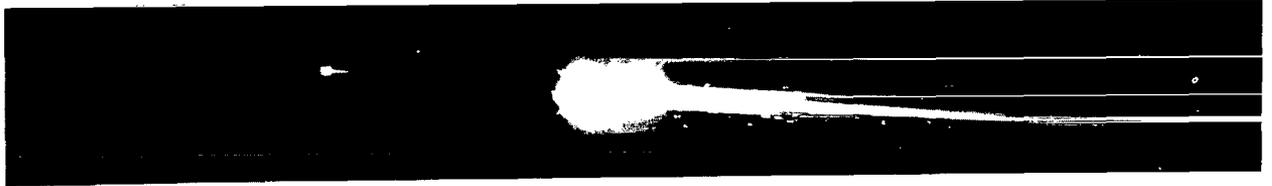
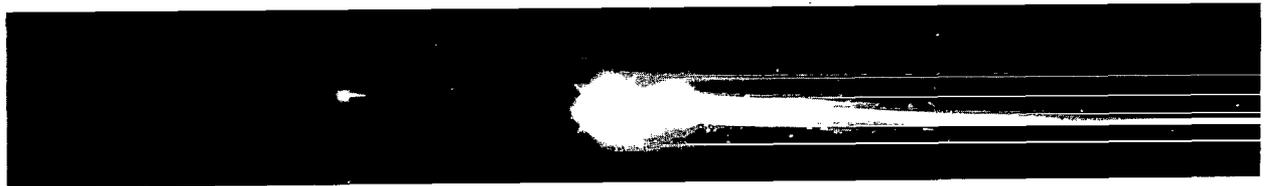
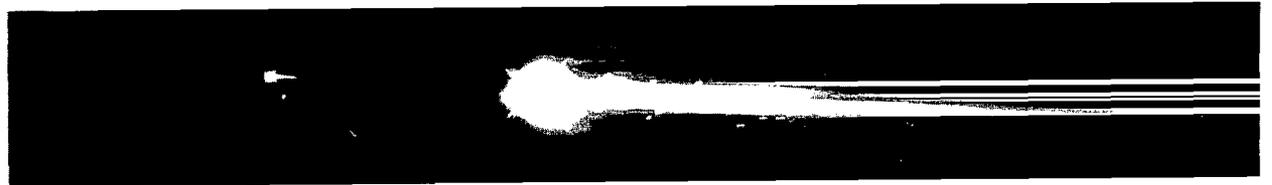
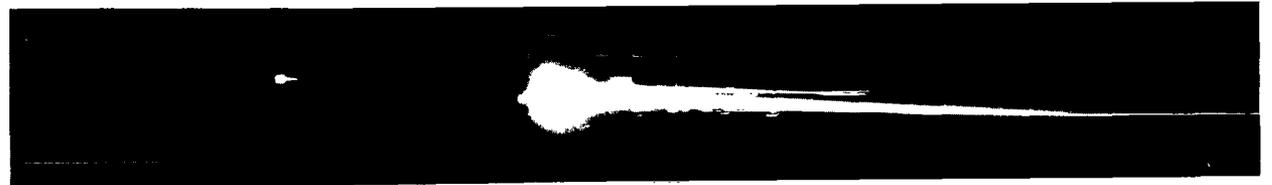
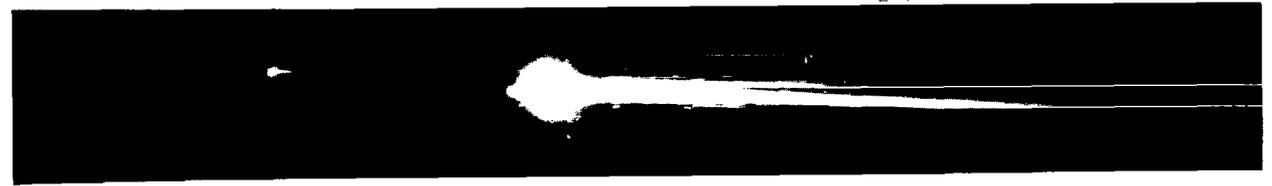
Beginning with photograph 5J at 1637.887 seconds, an object can be noticed breaking away from the main body of the spent Antares section. Because of its higher  $W/C_{DA}$ , it is not being decelerated as rapidly as the larger portions.

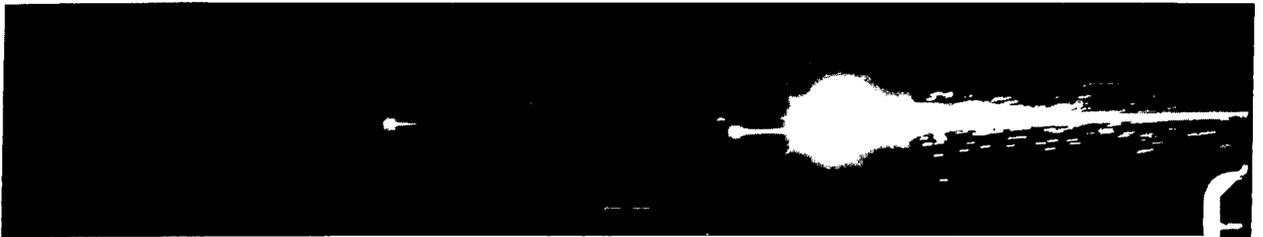
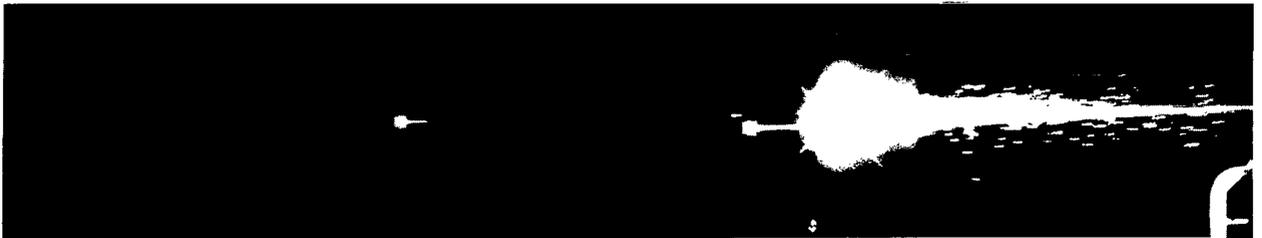
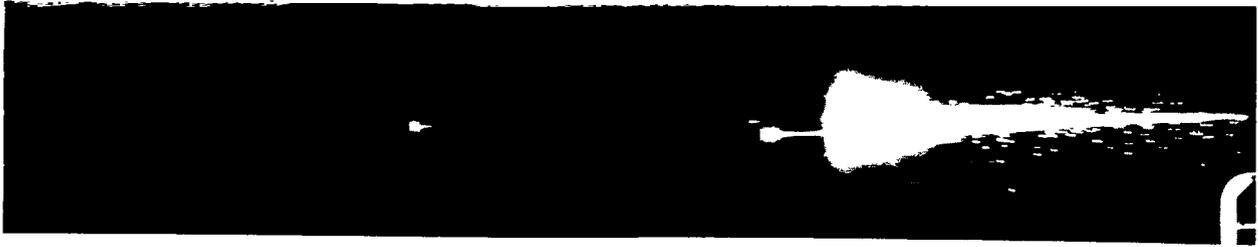
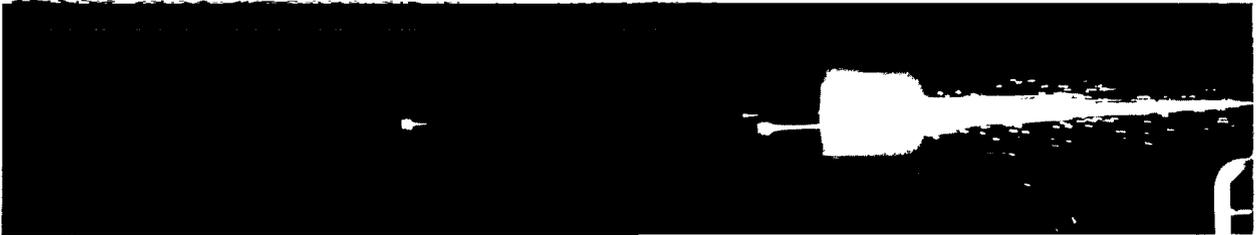
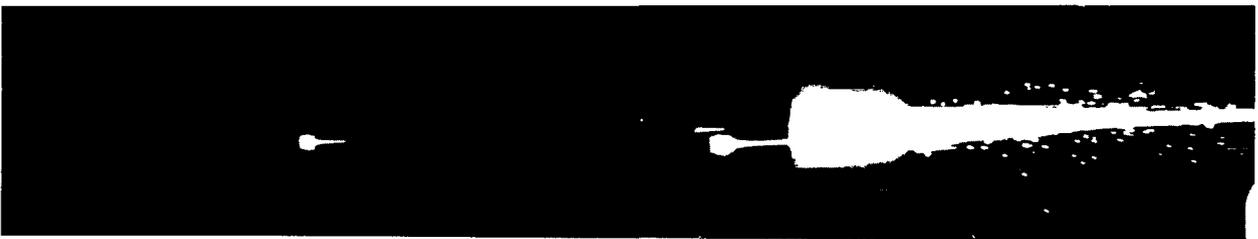
The photographs of sequence 6 began 0.04 second after activation of the reentry timer. The timer was activated when the reentry package experienced a 10.4g deceleration. During this sequence, severe breakup of the spent Antares is apparent. The separation distance between components continues to increase, and outgassing and afterbody ablation of the reentry package becomes more pronounced. The separation distance between the reentry package and the nearest separated piece of the spent Antares has increased to a distance of 925 meters in photograph 6E.

During sequence 6, the reentry-package velocity changed from 11 130 m/sec at 1639.155 sec to 11 117 m/sec at 1639.288 sec.

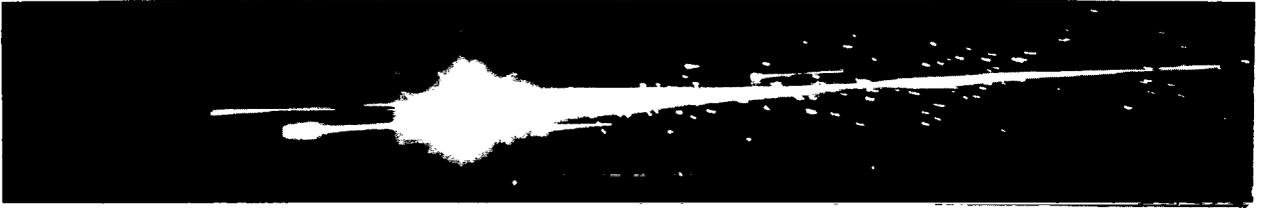
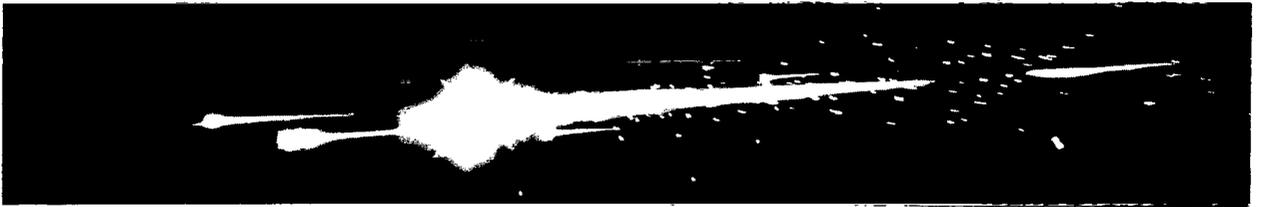
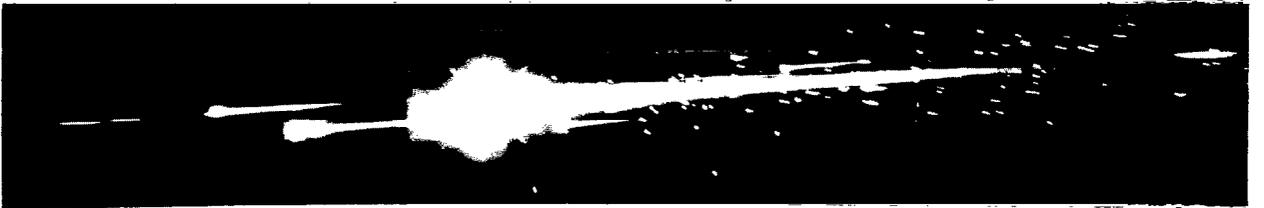
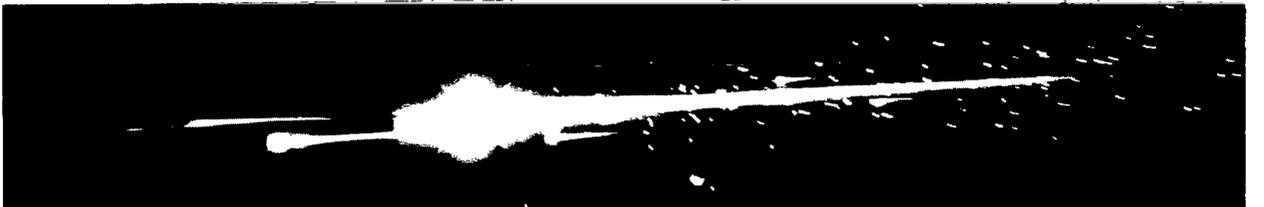
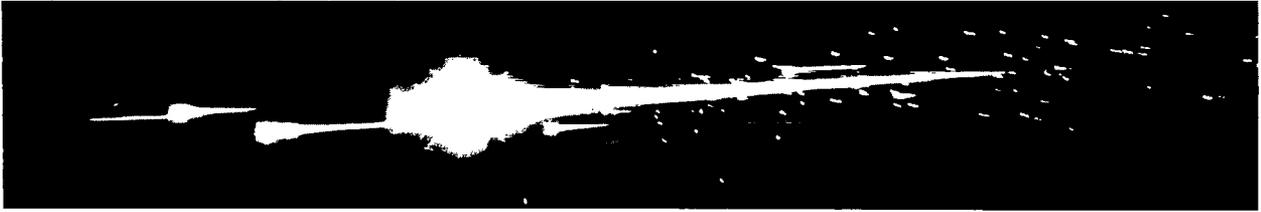
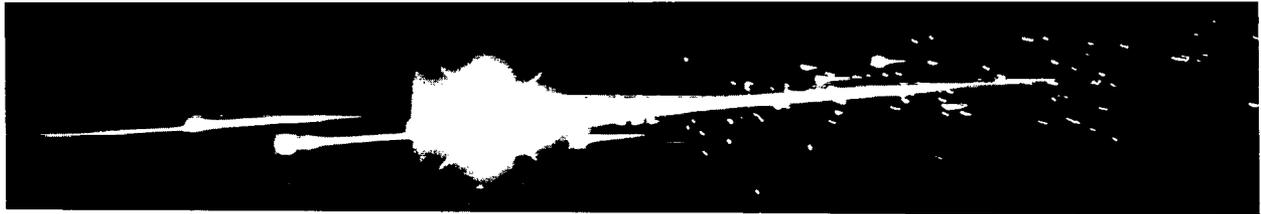
Sequence 7 does not show the reentry package, since it has moved out of the field of view to the left. This sequence provides the first indication of the melting beryllium calorimeter as a bright well-defined wake. On the color photographs, this wake is distinguished by its red color. Prelaunch calculations predicted that the beryllium should begin to melt at 1640 seconds, and the photograph recorded first visible indication of melting beryllium at 1640.155 seconds.

During sequence 7 the reentry-package velocity changed from 11 020 m/sec at 1640.155 sec to 10 984 m/sec at 1640.421 sec.

Event	Time from launch, sec	Photographic record	Telemetry data
Tumble-motor ignition	1616.43	Figure 7	No
First-beryllium-calorimeter melt	1640	Sequence 7A	Yes
First-ablation-shield ejection	1642.12	Sequence 8	Yes
Second-beryllium-calorimeter melt	1645.5	Sequence 11	Yes
Second-ablation-shield ejection	1647.53	Sequence 14	Yes

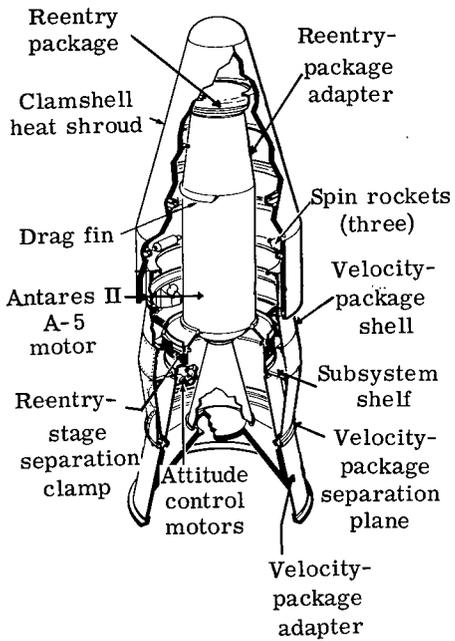
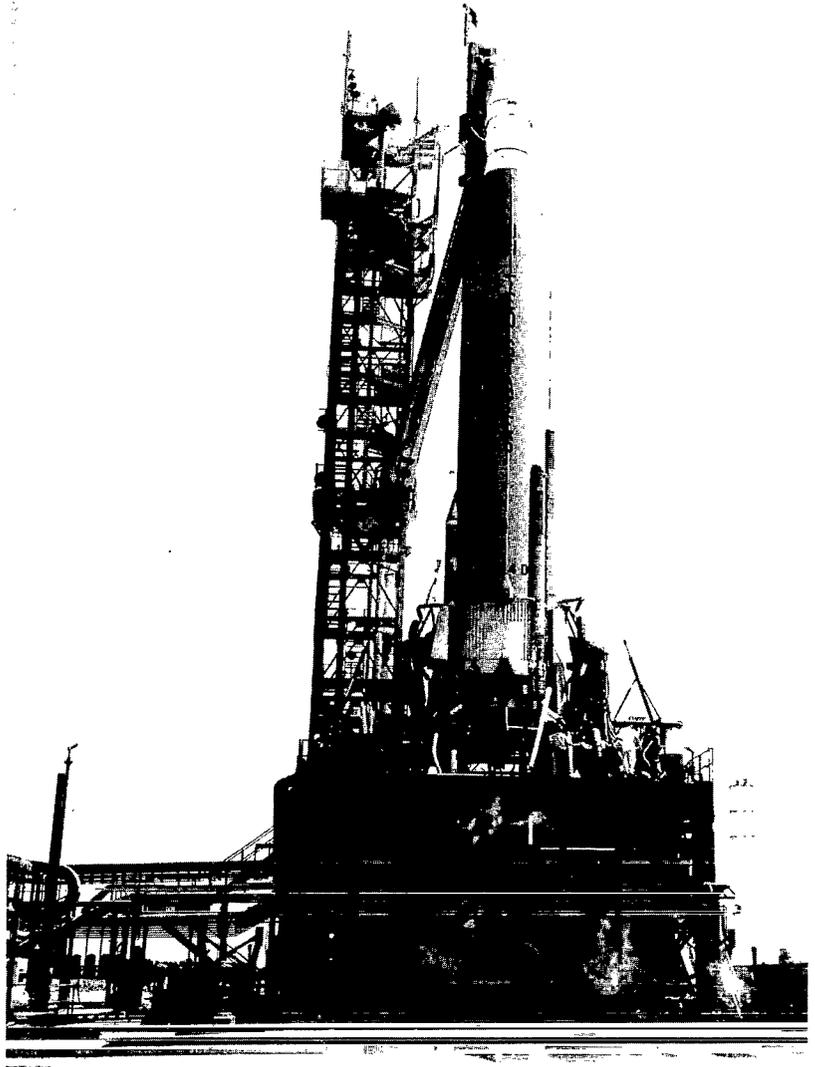
Figure 1.- Project Fire space vehicle.

(a) Launch configuration and cutaway view of spacecraft.

In order to gather the desired heating data during atmospheric reentry at speeds near 11 300 meters per second, a highly instrumented reentry package having a diameter of 67.2 centimeters and weighing 86.54 kilograms was accelerated back into the earth's atmosphere from a ballistic trajectory by a velocity package. The velocity package utilizing an Antares II-A5 solid-propellant rocket motor and its own guidance and control system was designed to provide spin stabilization, the required thrust, and attitude control to place the reentry package in a planned reentry flight path at the desired velocity. This spacecraft combination composed of the reentry package and the velocity package was lifted into a ballistic trajectory down the Eastern Test Range by an Atlas D launch vehicle (see fig. 1). A more detailed description of the space-vehicle hardware may be found in reference 1.

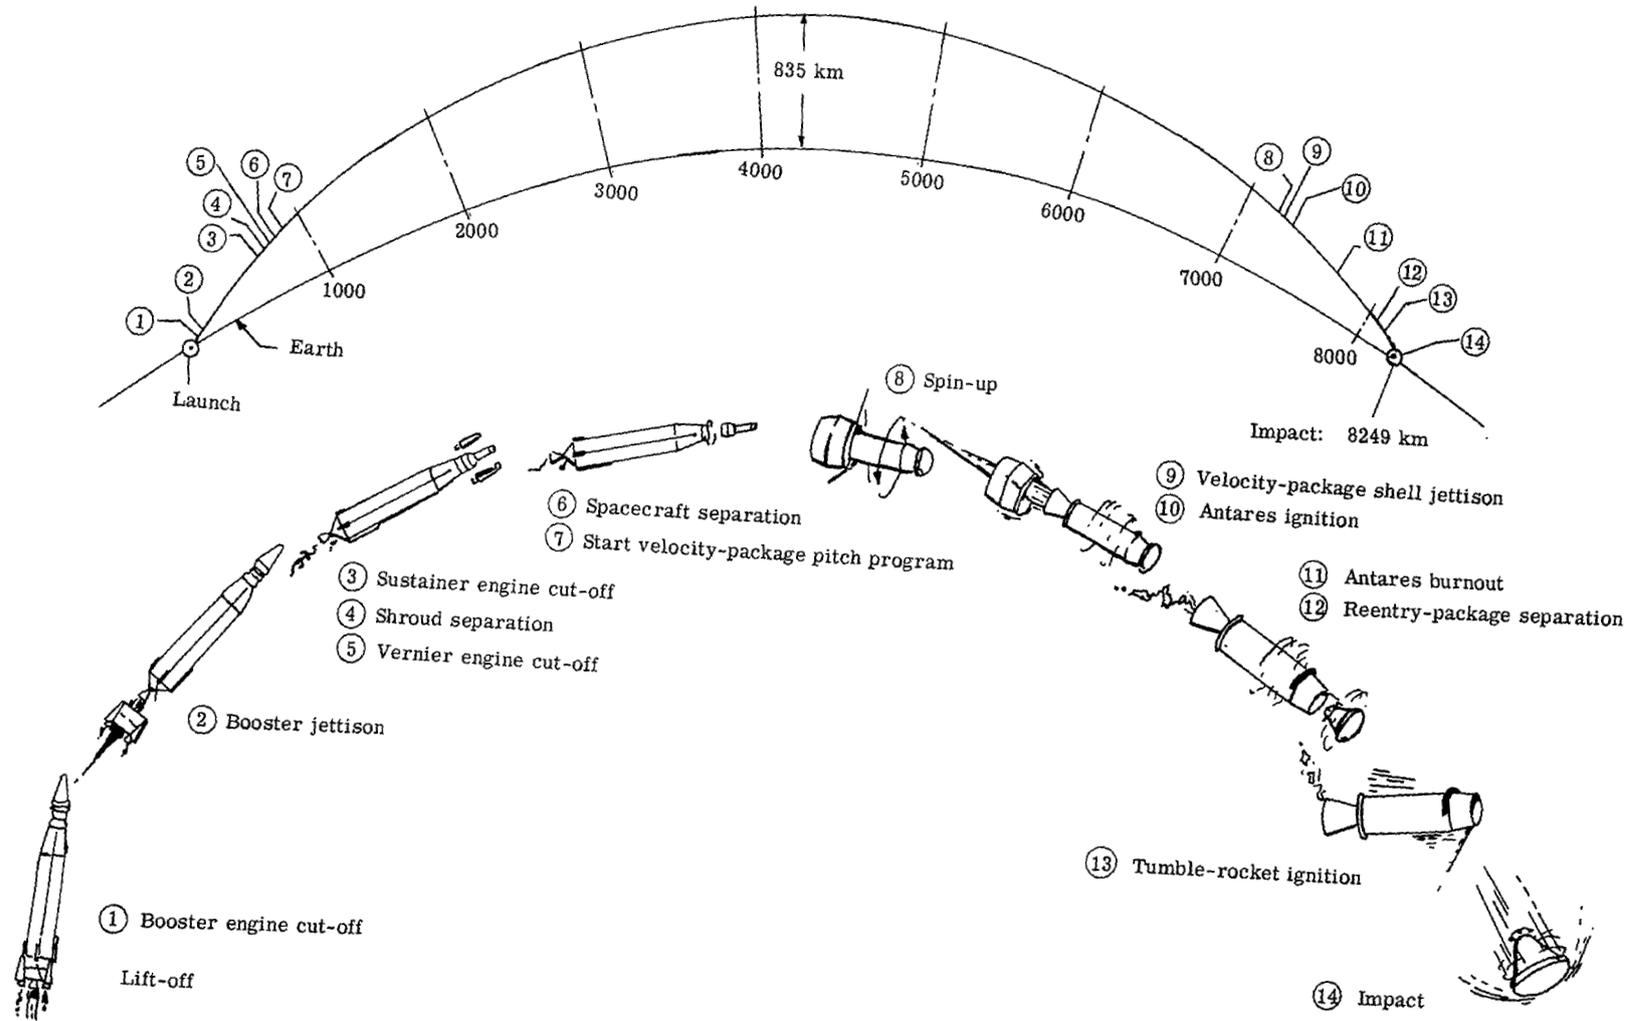
Figure 1.- Concluded.

(b) Vehicle trajectory and flight sequence of events.

The specific times of occurrence of the major events for both Fire I and Fire II are listed in table III. Following launch of the space vehicle, ejection of the protective shroud, and separation of the spacecraft from the launch vehicle, the spacecraft entered a coast phase during which the velocity-package guidance system reoriented the spacecraft to a reentry attitude of  $-15^{\circ}$  to the horizon. After coast through apogee the velocity package was programmed to deactivate its guidance system, ignite the spin rockets to spin stabilize the reentry package, separate the velocity-package shell, and ignite the Antares solid-propellant motor. Following burnout of the Antares motor, the reentry package was separated from the spent motor case and the small rocket motors on the reentry-package adapter were ignited. A tumble rocket motor was used on the Fire I reentry-package adapter; a despin rocket motor and a retrorocket motor were used on the Fire II adapter. These motors were positioned to despin the spent Antares motor, cause it to tumble, and translate it from the reentry-package flight path. During the Fire I reentry the separation distance between the reentry package and the spent Antares became so small that the flow field from the spent Antares induced some undesirable body motions in the reentry package (ref. 1). Mounted between the Antares motor and the reentry-package adapter on Fire II was a large asymmetrical drag plate to increase the

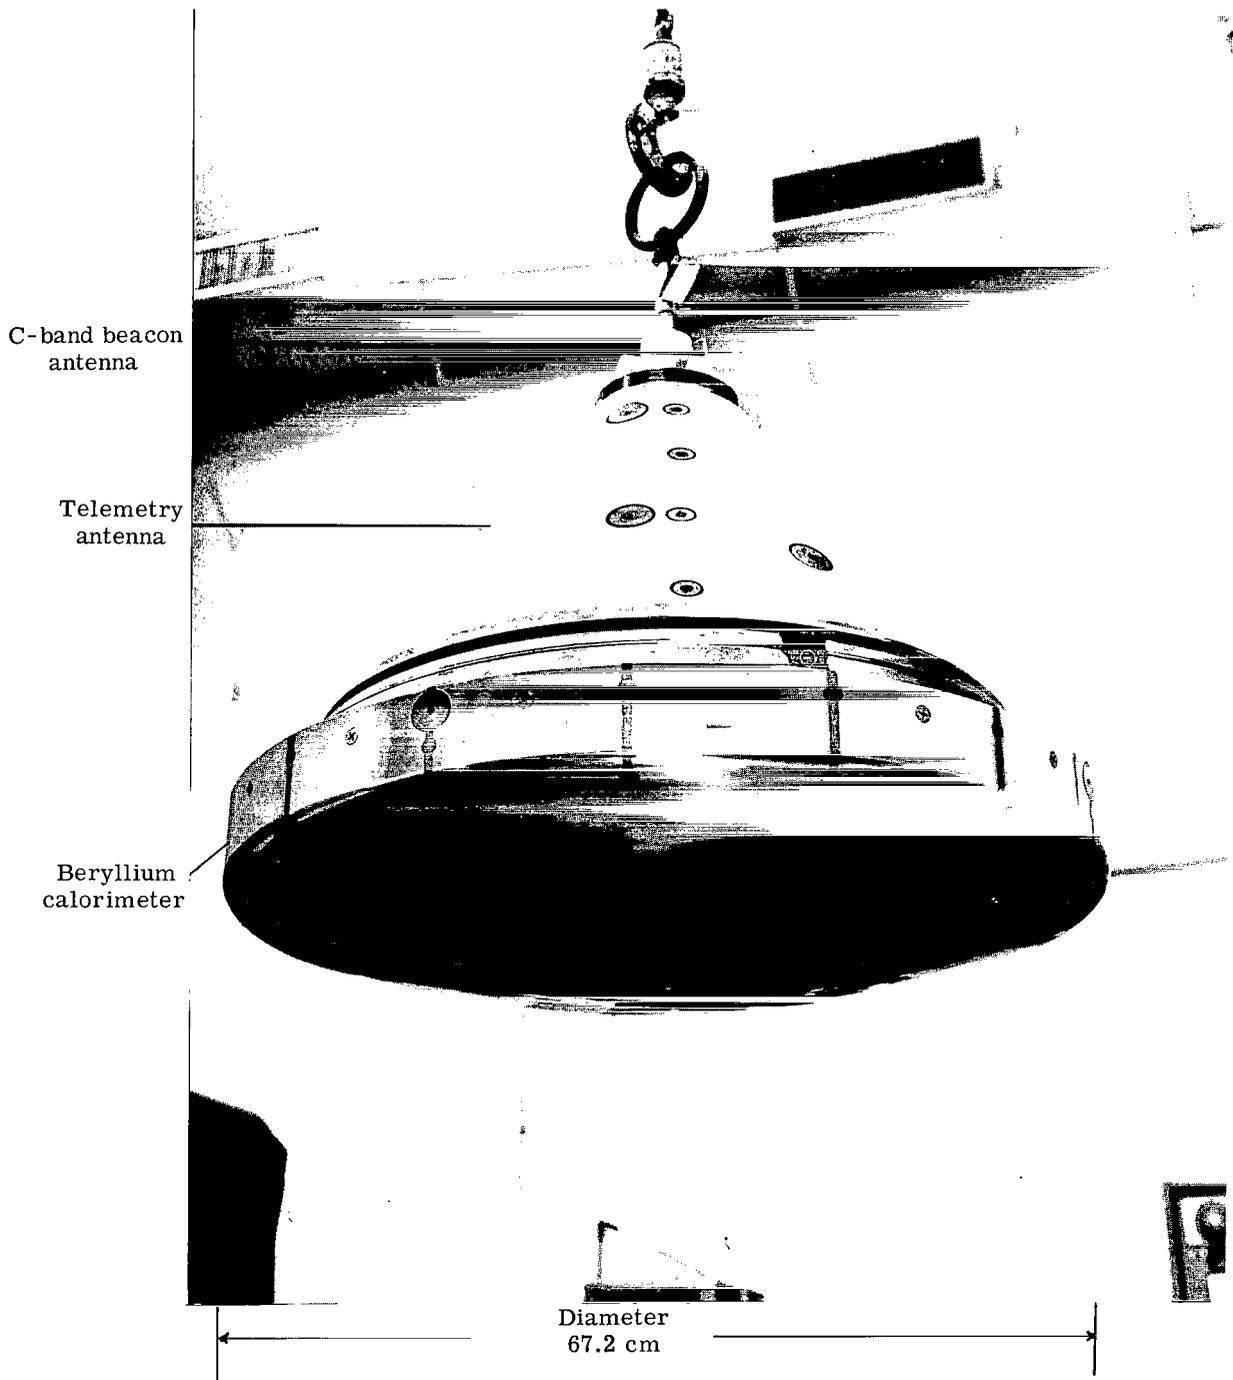
Figure 2.- Reentry package.

(a) Exterior view.

Figure 2 presents photographs of the exterior and interior of the reentry package and a drawing showing the arrangement of the forebody calorimeters and ablation shields. The afterbody structure was primarily fiber glass with a phenolic asbestos cover which was coated with silicone elastomer containing silica microballoons. The afterbody was a 66° cone attached to the forebody by an aluminum flange. The beacon and telemetry

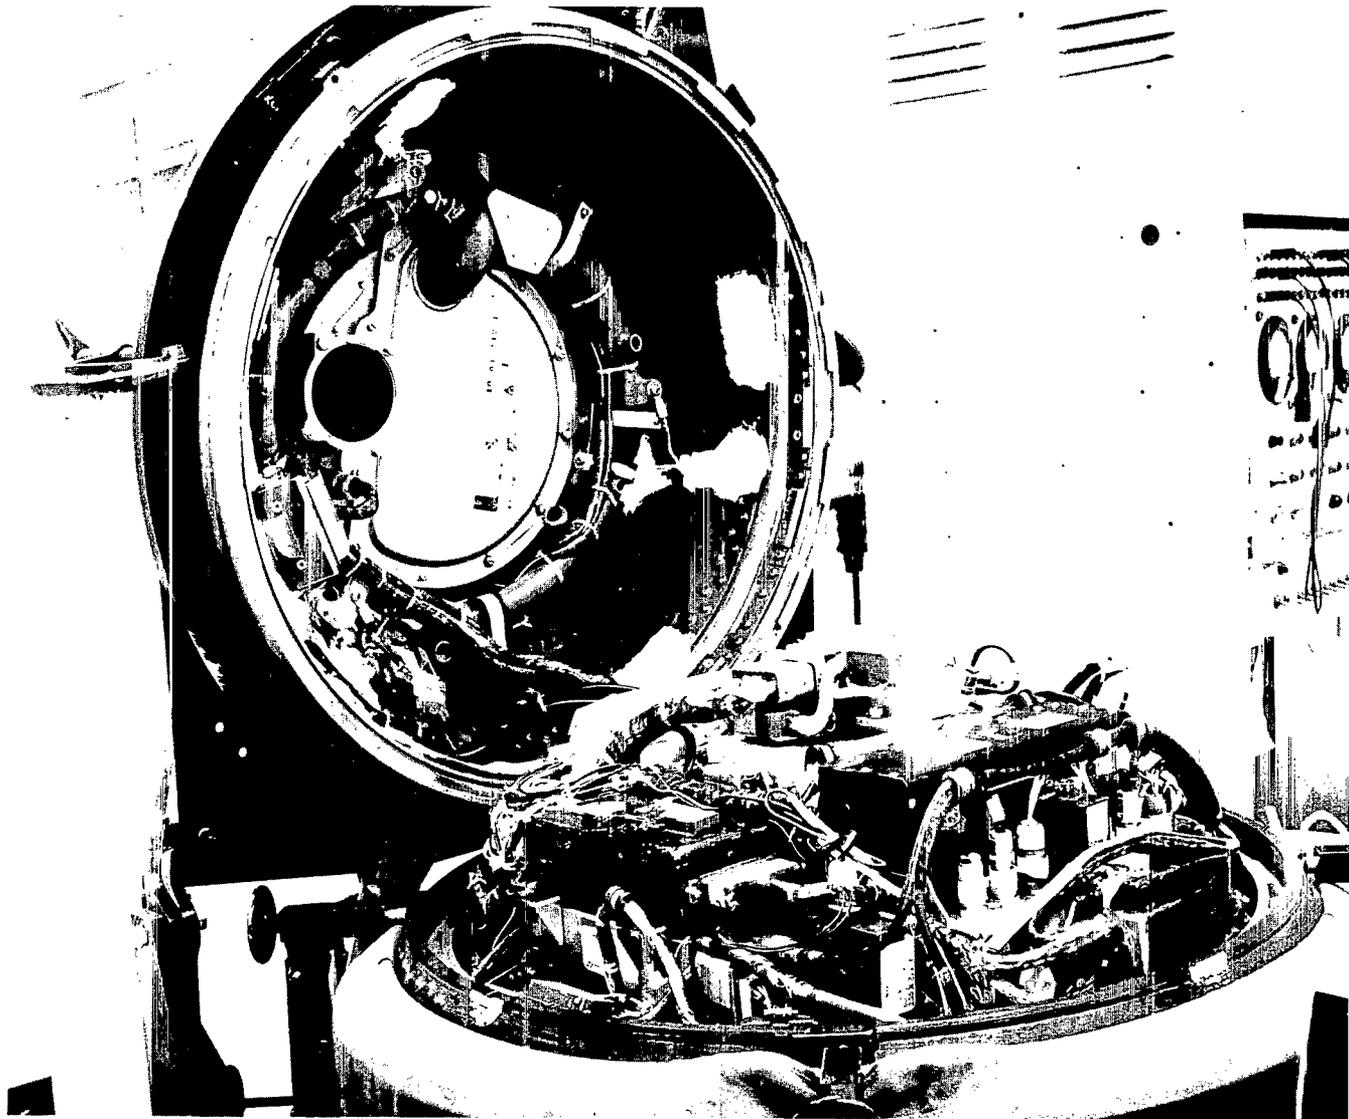
Figure 2.- Continued.

(b) Interior view.

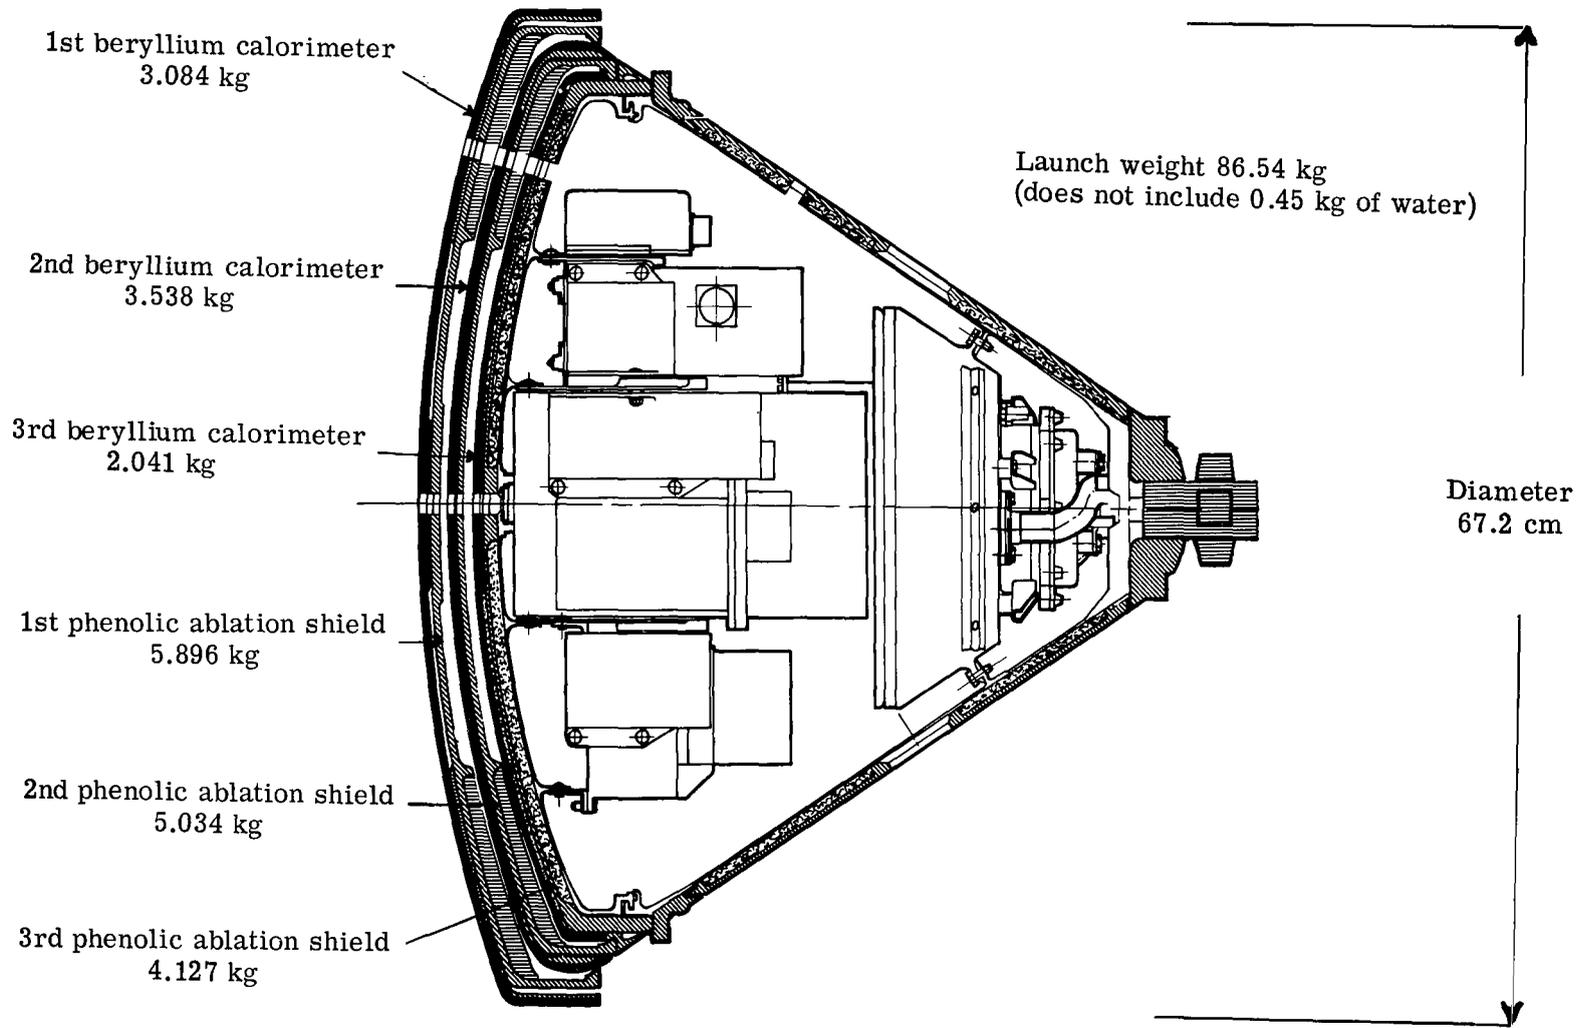
Figure 2.- Concluded.

(c) Sectional sketch showing reentry-package details.

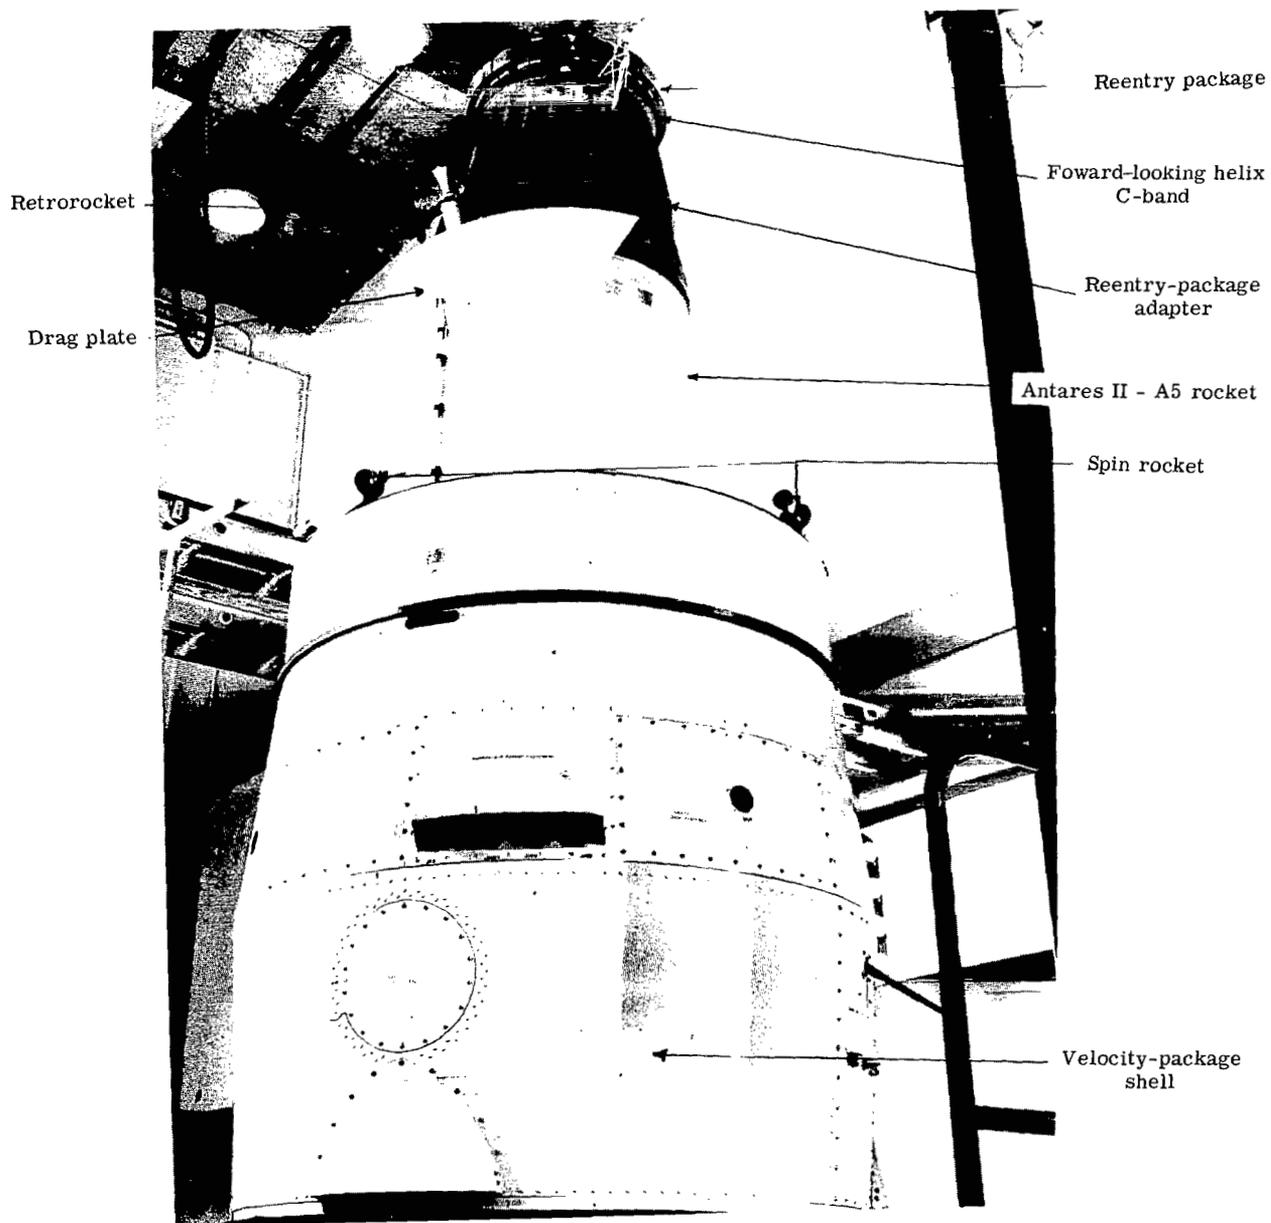
Figure 4.- Fire II spacecraft.

(a) View with heat shroud removed.

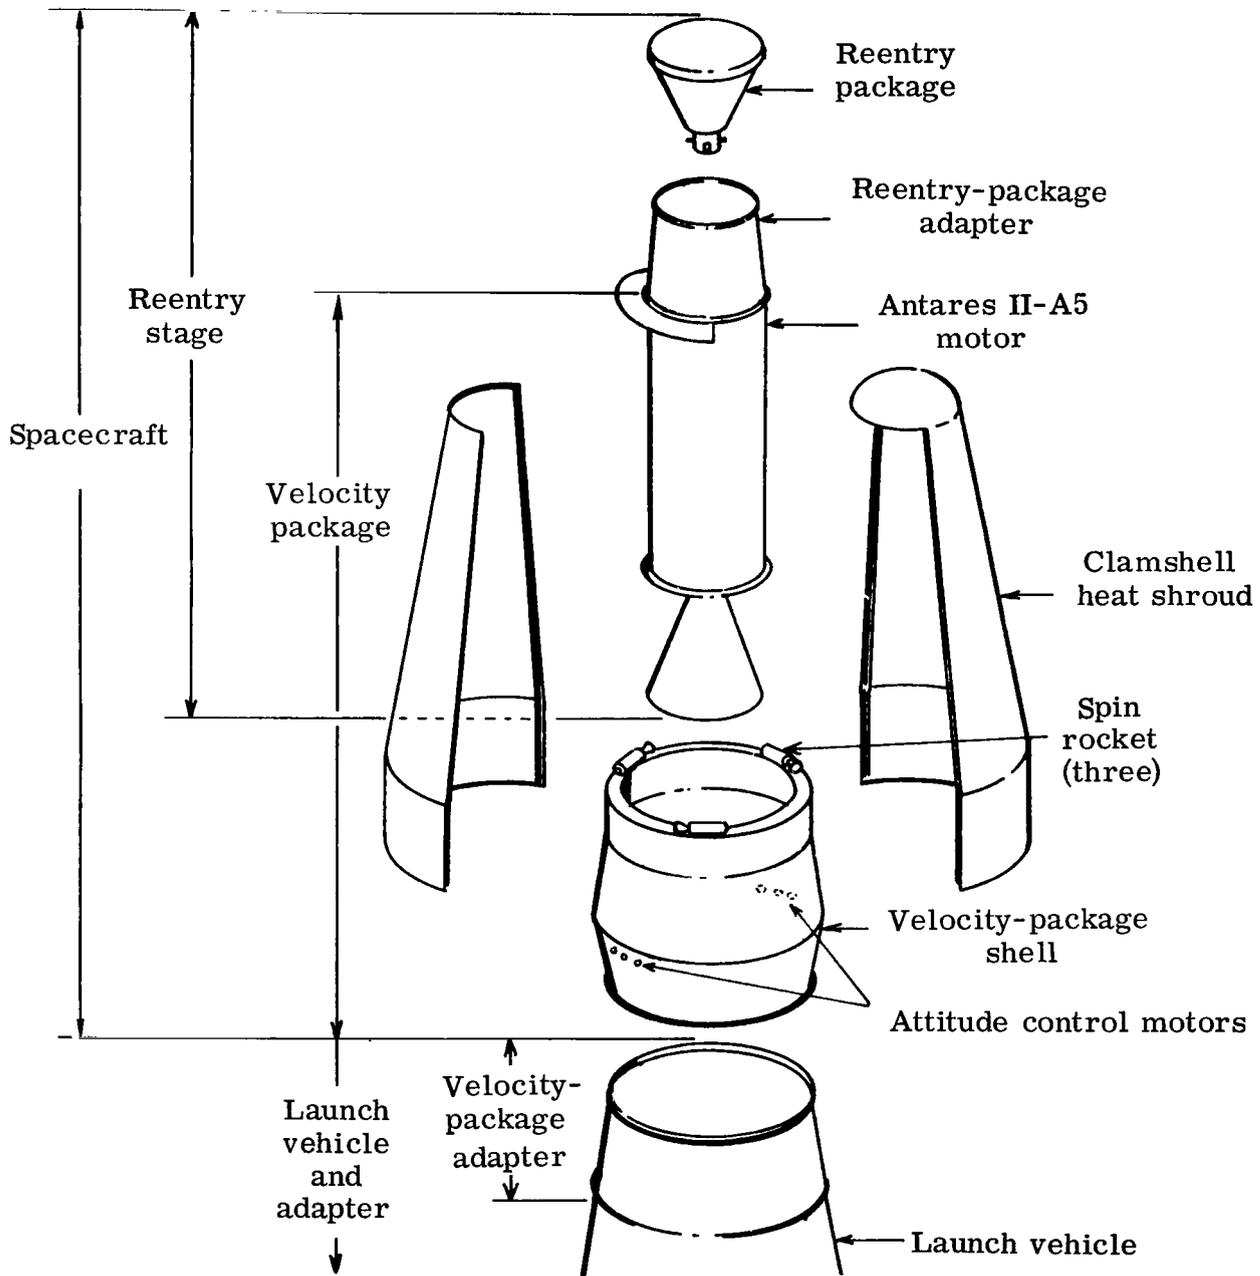
Figure 4.- Continued.

(b) Exploded view.

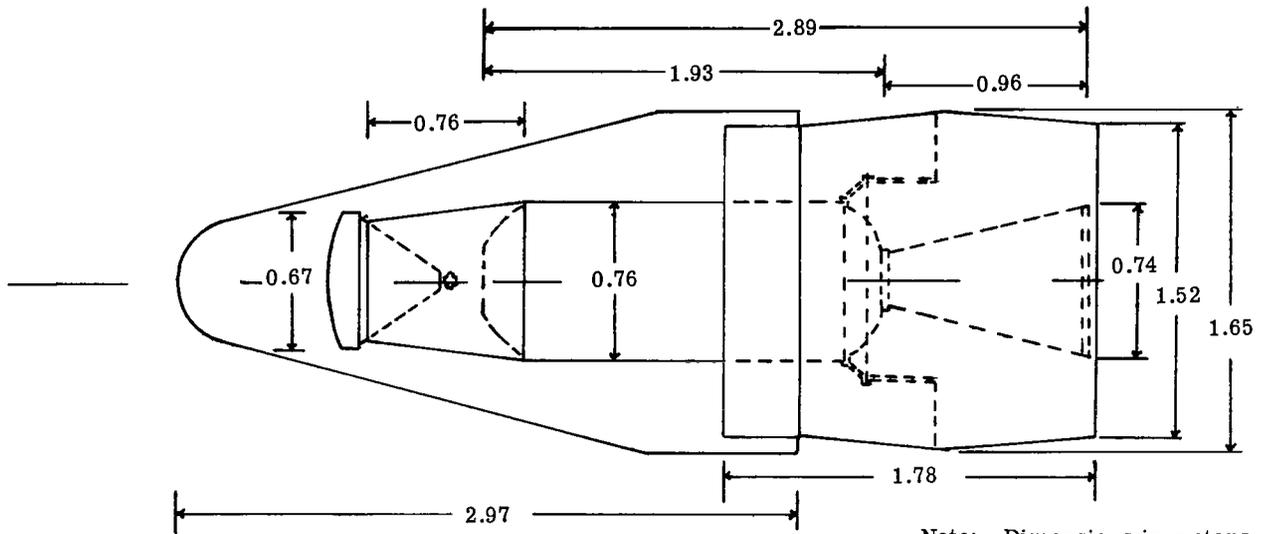
Figure 4.- Concluded.

Note: Dimensions in meters

Item	Weight, kg	Primary material	Item	Weight, kg	Primary material
Heat shroud (2 pieces)	133.66	Fiber glass Magnesium Aluminum	Spent Antares (which includes next three items)	143.73	Fiber glass Carbon
Reentry package	86.57 *	Beryllium Phenolic asbestos Aluminum	Reentry-package adapter	27.08	Fiber glass
Velocity-package shell	358.04	Aluminum	Drag plate + counterbalance	8.16	Aluminum Brass
			Motor adapter + balance mass	13.05	Aluminum Copper

(c) Physical characteristics.

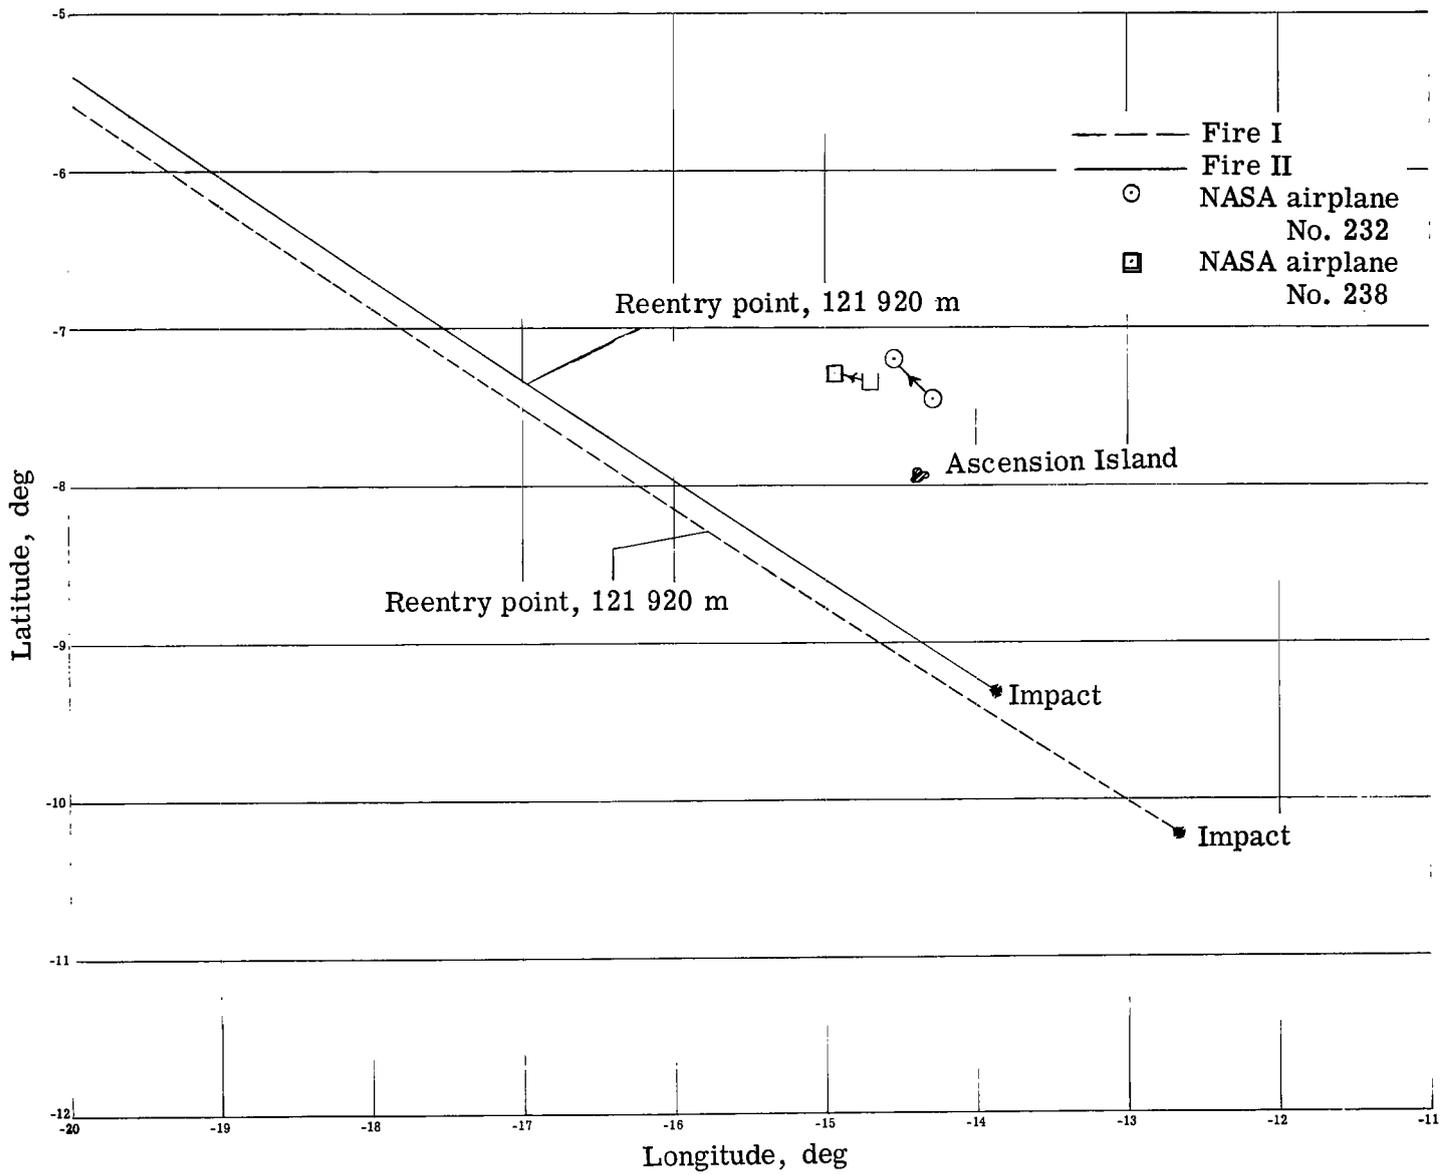
Figure 5.- Fire II reentry ground track.

For the Fire II flight it was decided to move the spacecraft reentry track 18 kilometers closer to Ascension Island and to move the impact point uprange 150 kilometers. This trajectory change provided a much better opportunity for obtaining good optical coverage and also placed the reentry-package telemetry antenna pattern in its best relationship to the ground station during the delayed playback period. The Fire I and Fire II ground tracks in relation to Ascension Island are illustrated in figure 5.
